# Arboricultural Assessment Report

Capdoo

Project No.	Project name	Date	Revision
TCAP001	Capdoo	26/03/19	A

## Report Prepared by

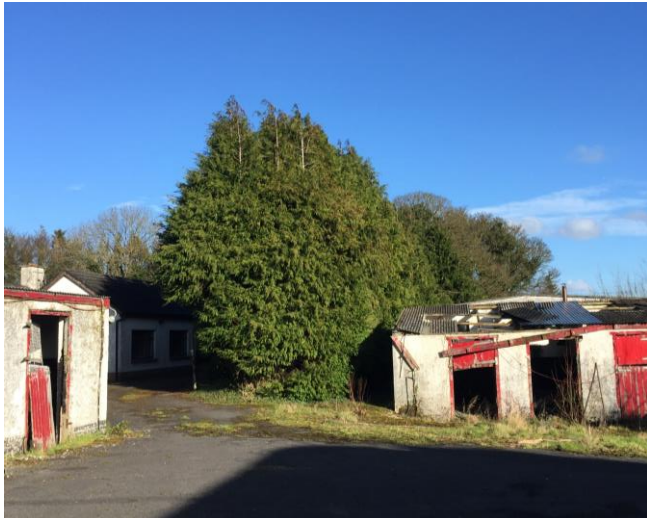
The trees and hedges around the house and stable area include a large Leyland cypress hedge (*xCuprocyparis leylandii*) along the entrance road to the house (image 2). The Leyland hedge is large, casts extensive shade and is a management liability. A large mature sycamore (*Acer pseudoplatanus*) is located at the entrance to the house on the eastern boundary (image 3) with further large mature ash (*Fraxinus excelsior*) and sycamore trees on the boundary with a neighbouring property near the eastern boundary of the site.

**Image 2.** Leyland cypress within stable yard

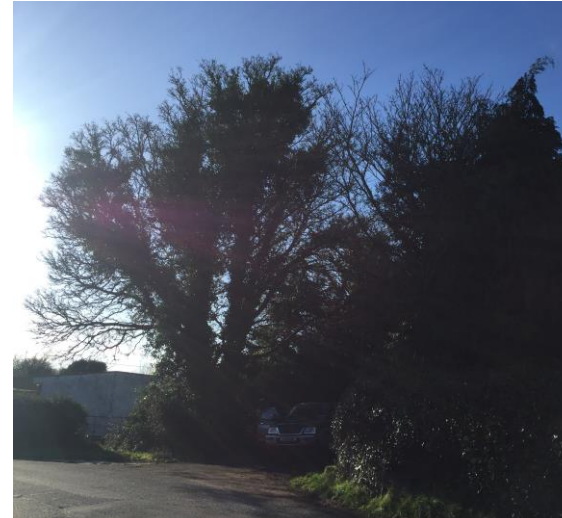
**Image 3.** Mature sycamore at eastern entrance to site

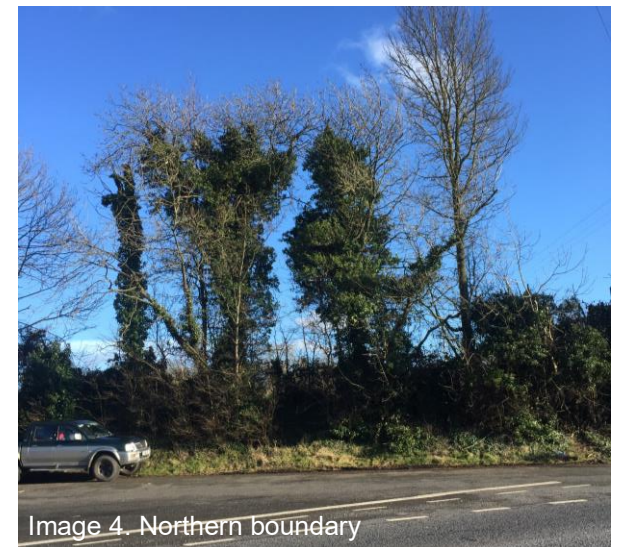
The trees on the northern boundary are a mixture of ash and sycamore with occasional elm (*Ulmus procera*). They range from young to old and their condition is mixed with strong competition between trees a factor in their condition and form (image 4). Very limited management inputs have led to very heavy ivy establishment which can be a contributor to a windsail effect and tree failure during storm events.

**Image 4.** Northern boundary

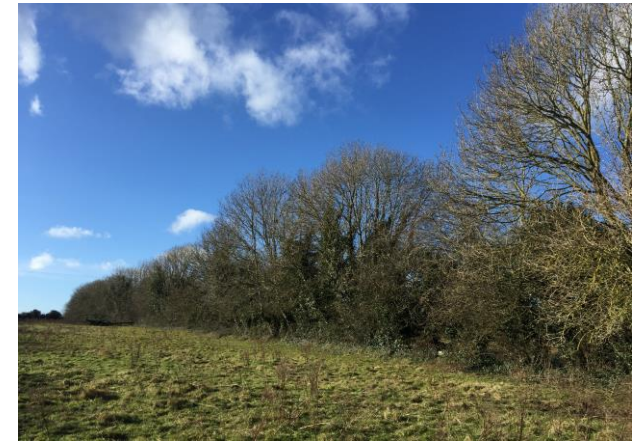
The hedgerows were most likely managed as clipped hawthorn (*Crataegus monogyna*) with occasional standard trees however due to limited management inputs the hawthorn element in most instances has either been shaded out or become overgrown. With the exception of one hedgerow, standard trees are relatively rare. Where they do occur, the main species represented is ash. The vast majority of these trees are multi-stemmed specimens (image 5) which developed from continual cutting back. When neglected, as in this situation it results in trees of poor structural integrity as areas of weakness develop between stems.

Image 5. Hedgerow with multi-stemmed ash

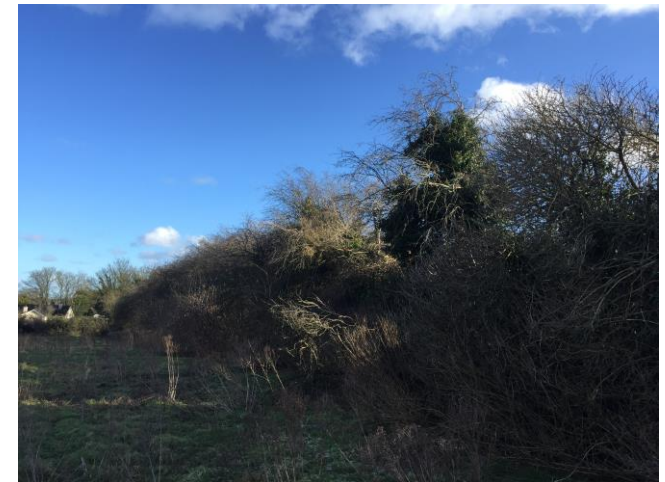
The extensive bramble (*Rubus fruticosus* agg) growth (image 6) which has developed due to limited management inputs has smothered out most of the potential ground flora within the hedgerows limiting these elements to occasional ferns and grasses. Ultimately the hedgerows are degraded in quality due to mismanagement and neglect.

Image 6. Typical hedgerow composition with hawthorn in poor condition and extensive bramble growth smothering ground flora
