Title: STAGE 1 ROAD SAFETY AUDIT

Capdoo Link Road, Clane Co. Kildare.

Client: DBFL Consulting Engineers.

Date: April 2019

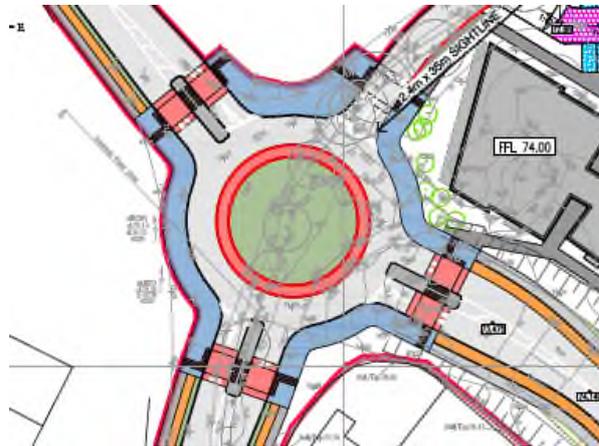
Drawing 162074-2001

It is unclear if the proposed roundabout on the R407 will be able to cater for the swept path of heavy goods vehicles. The regional road routes have a high percentage of heavy goods vehicles and without sufficient space to accommodate the swept path of these vehicles they could overrun into the areas for vulnerable road users or cause material damage to roadside furniture.

It is recommended that a swept path analysis is carried out at the roundabout for heavy goods vehicles including u-turns. If the vehicles cannot undertake the movements at reasonable speed and with adequate clearance to roadside furniture such as directional signage then the geometry of the roundabout should be modified.

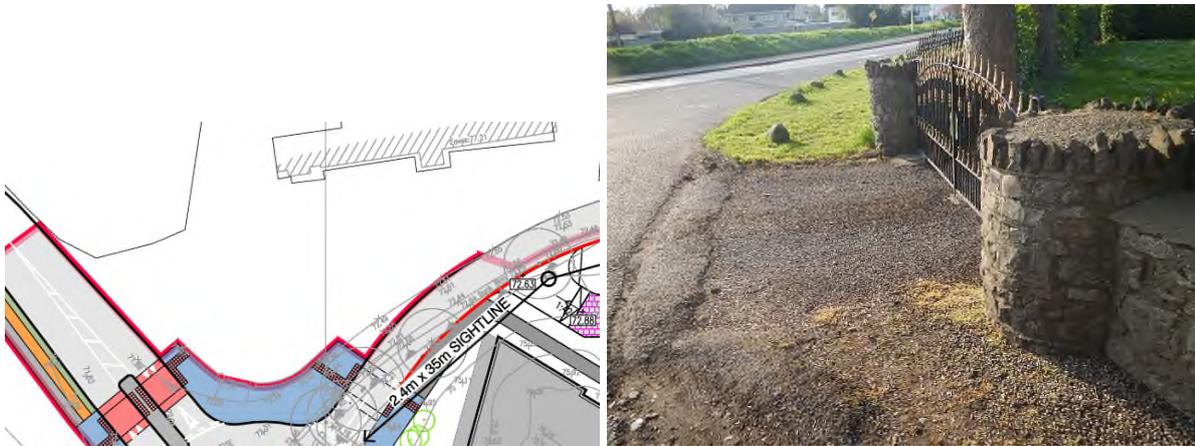
Drawing 162074-2001

It is unclear if the design caters for access to the premises on the north-east corner of the proposed roundabout. There is a risk that the revised access detail may lead to conflict with vulnerable road users on the footpath/cycle tracks or at the controlled crossings.

It is recommended that the access to the private property be included in the design and located where it does not have a negative impact of the safety of vulnerable road users.

3.1	Y	Y		
3.2	Y	Y	<p>The existing access for the private dwelling is now shown on the roundabout layout plan drawing 162074-2001 Rev A.. We note that the Capdoo Inner Relief Road included a DMRB style roundabout at this location when it received Part VIII Planning from Kildare Co Co previously and the existing access location was retained in that arrangement. The provision of a DMURs style roundabout with this revised scheme enhances safety by reducing entry speeds and improving crossing facilities etc for vulnerable road users. As per drawing 162074-2001 Rev A there is sufficient setback distance from the dwelling entrance to back of shared path to allow the driver & vulnerable road user adequate visibility on approach. The bollards provided on the access also highlight to the pedestrian / cyclist on the shared path that an entrance exists at that location. The driver entering the property will yield to pedestrians / cyclists on the shared path and will be visible to all slow moving vehicles entering / exiting the roundabout.</p>	Yes

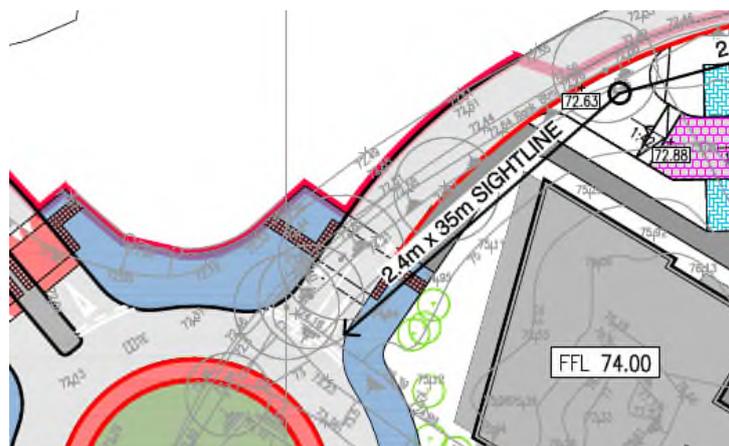
Drawing 162074-2001

The carriageway width of the L5078 appears narrow for two vehicles to meet. If a give take system has to be used drivers may stop on the circulating carriageway of the roundabout which could result in rear end collisions.

Ensure the carriageway width of the L5078 on approach to the roundabout can accommodate two passing vehicles. A swept path analysis should be carried out.

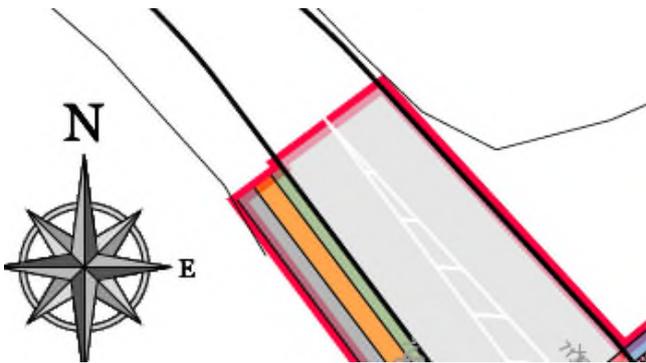
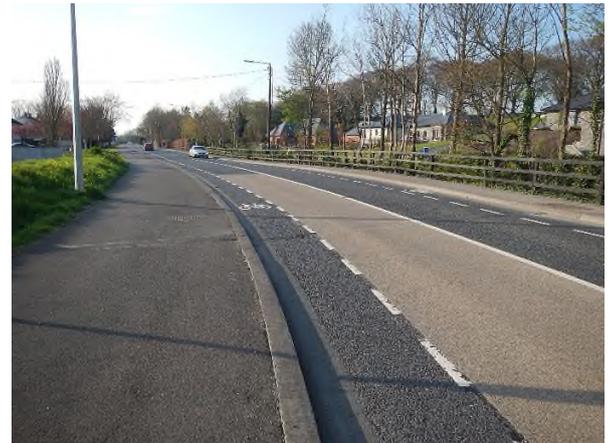
Drawing 162074-2001

The existing cycling facilities on the R407 are on-road and the proposed cycle facilities are off-road. It is unclear how it is proposed to provide a transition from on to off-road and vice versa. Sudden changes in cyclists location on the carriageway could lead to drivers being unable to react resulting in collisions.

It is recommended that the transition details be developed during the detailed design such that cyclists can safely travel on the R407 and the new link road.

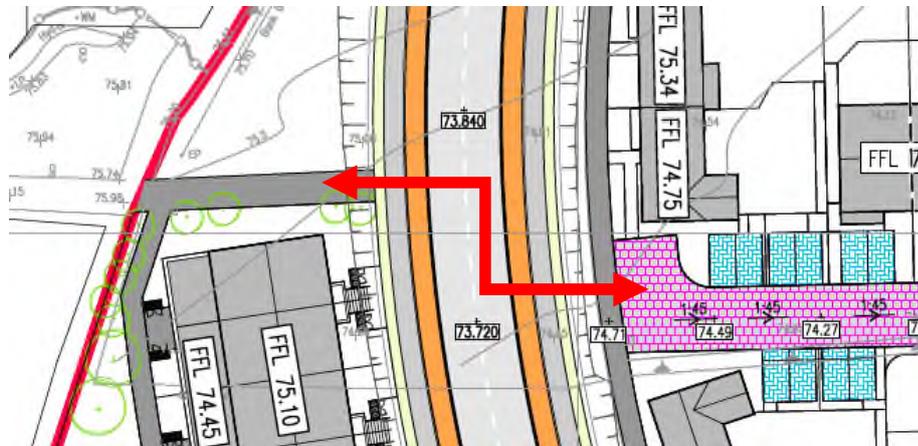
Drawing 162074-2003

There are potential desire lines for pedestrians from College Road East to the internal cul-de-sac on the eastern side of the Link Road and similarly from Mainham Woods. There is however no provision for pedestrians or cyclists to cross at these locations. Without crossing facilities there is an increased risk of a collision with vulnerable road users.

It is recommended that formal pedestrian crossings of the Link Road are provided at the desire lines.

3.3	Y	Y		
3.4	Y	Y		
3.5	N	N	<p>The proposed toucan crossing has been located to maximize connectivity between the western and eastern portion of the development (i.e. between the duplex units in the south-west corner / the creche and open space areas on the eastern side of the Capdoo Link Road).</p> <p>Connectivity from College Road East to destinations such as the creche, the open space area on the eastern side of the Capdoo Link Road and the general town center (south of the site via Capdoo Lane) are easily facilitated without provision of a second pedestrian crossing on Capdoo Link Road.</p> <p>Introduction of a second crossing adjacent to College Road East as recommended would result in two signalized crossings within 80m along the Capdoo Link Road.</p>	Yes

Paragraph No. in Safety Audit Report	Problem accepted (yes/no)	Recommended measure accepted (yes/no)	Alternative measures (describe)	Alternative measures accepted by Auditors (Yes/No)
			We note there is no proposal to facilitate connectivity between Mainham Woods and the Capdoo Link Road (due to significant level differences).

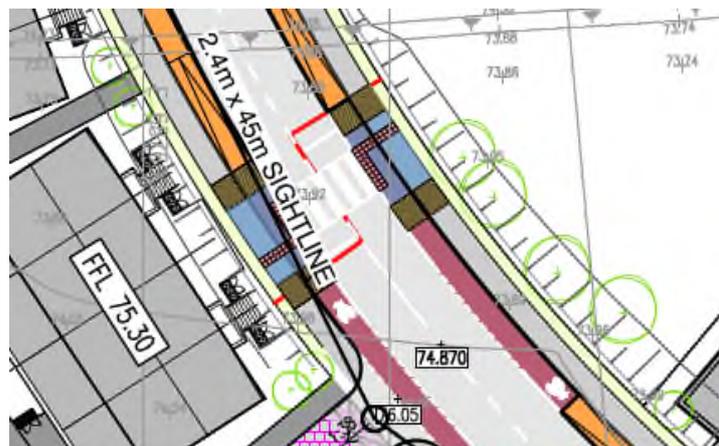
Drawing 162074-2003

The signalised toucan crossing at the mid-point of the Link Road is located where there is an on-road cycle lane. This could lead to drivers inadvertently travelling over the areas where pedestrians cross resulting in damage to the vulnerable road user infrastructure.

It is recommended that the crossing be located where there is off road cycle track leading into a shared use area.

3.6	Y	Y	The cycle lanes (or road / off road) have been amended so that the crossing is sited where the cyclists are on road. Tactile paving & signal poles have been relocated to the edge of the pedestrian footpath (i.e. clear of the on road cycle lane)	Yes

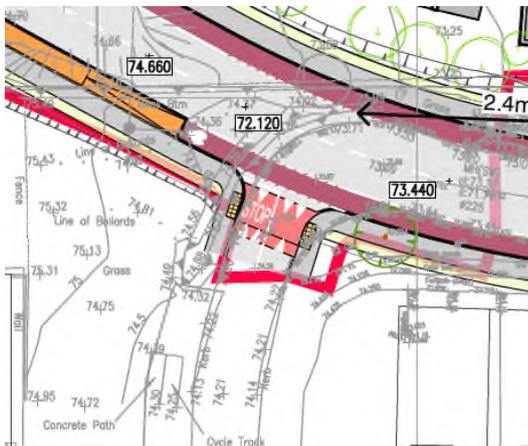
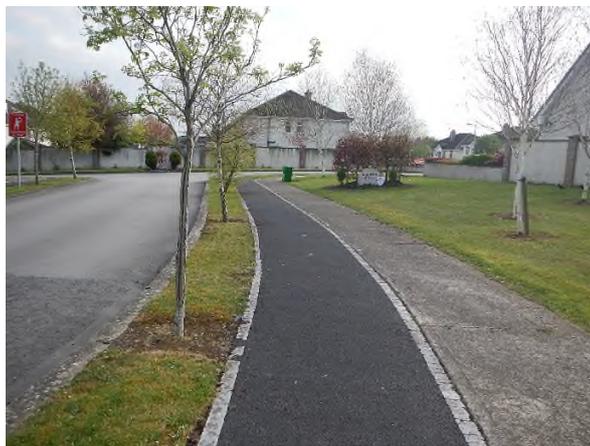
Drawing 162074-2003

There are existing segregated footway and cycle way facilities in Capdoo Park residential estate. The proposed Link Road vulnerable road user facilities do not tie in with these segregated facilities. This may result in cyclists having to travel on the carriageway where they would be at greater risk of being struck by passing vehicles and it would be a step down from the current facilities.

It is recommended that the design be modified to maintain segregated footway and cycleway facilities in Capdoo Park.

3.7	Y	Y/N	Proposed works at the Capdoo Link Road / Capdoo Park junction extend to the existing public ownership boundary line. Capdoo Park has not yet been taken in charge by KCC and it is not possible at this stage to modify the existing segregated footway / cycleway within Capdoo Park. We will advise this item to Kildare Co Co and they can extend to meet existing path / cycle path when Capdoo Park is taken in charge.	Yes
